Repair Hints

Service-Level 3 & 4

6610/7210/7250

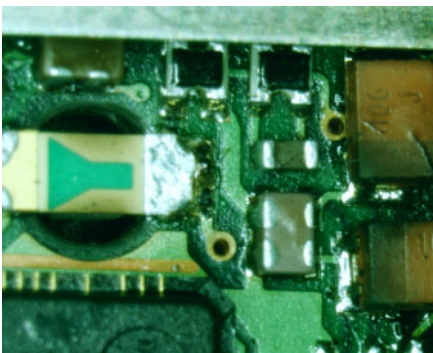
All replaceable (not underfilled) μ BGA components must be renewed after removing. Reflow with uncontrolled hot air fan is strictly forbidden! μ BGA must only be soldered with NMP approved μ BGA rework machines (e.g. Zevac/ OK-Metcal/ Martin) to get durable solder joints.

"rework" done with uncontrolled hot air

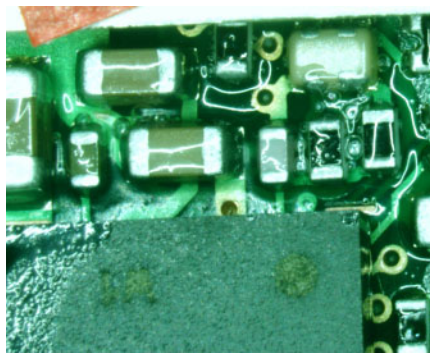
Use only recommended fluxtype and an appropriate amount of it – avoid drowning the PCB in flux as this will result in additional faults!

PCB drowned in flux

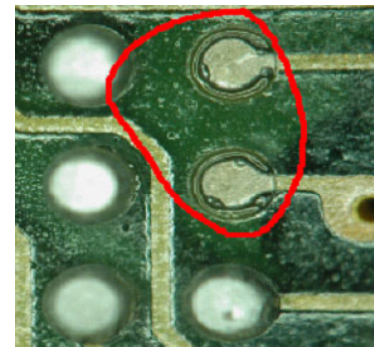
oxidated solderings

After removing a μ BGA check soldering points, if necessary rework oxidated solderings (broken balls) carefully by tinplating these areas with few flux and a hot soldering iron. Before placing a new component remove the tin and clean the PCB, e.g. with help of solder wick and flux cleaner such as "Kontakt LR".

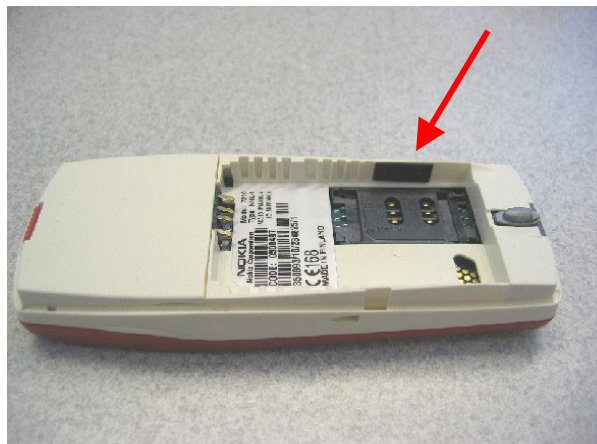
Place for battery gasket

Also for “phone powers down” it is risky if the phone loses contact to the battery for a couple of milliseconds; the phone powers off. By placing the battery gasket (NMP Code 9460594) on the C-cover, the battery will be fixed more tightly to the housing as shown in picture below *. The battery gasket must be installed to all NHL-4u/4j phones brought to service.

To ensure good contact between battery (BLD-3) and phone, the battery pads on the battery must be cleaned with isopropyl alcohol and a cotton bud each time the phone is brought to service.

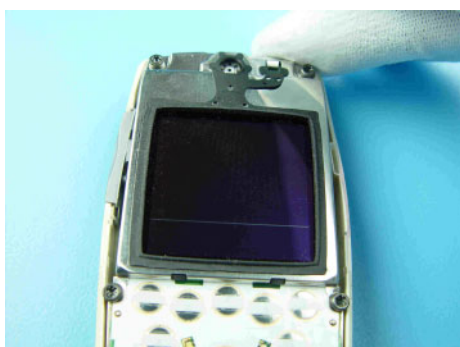
Missing line

If one of the faults shown in the pictures below appears on the display, change the color display (LCD module I004)

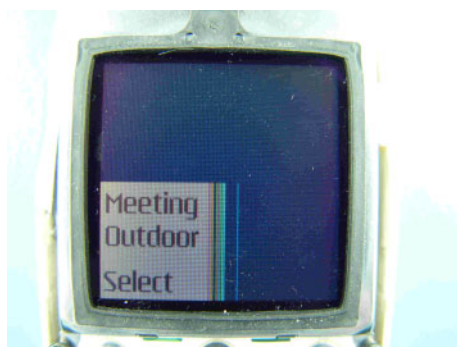
missing segments
