Repair Hints

Service-Level 3 & 4

6610/7210/7250

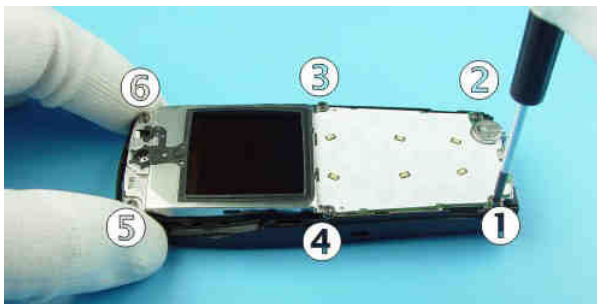
Disassembling (1-6) and assembling (6-1) order

To disassemble the phone, use a T6 screwdriver. Unscrew the 6 screws in the order shown in the picture below. To assemble the phone, use the reverse order with a Torx T6 Plus screwdriver and **torque of 17Ncm** for NHL-4/4u and **torque of 22Ncm** for NHL-4j.

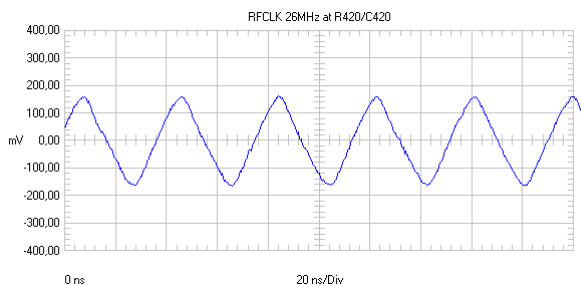
Figure 1 RFClk 26MHz

- RFCLK 26MHz at C420.
- 32kHz SleepClk at J404

If both signals are ok, probably the D450 Flash is faulty and has to be changed. After changing it is necessary first to flash the phone and then rebuilt IMEI/ESN and tune the phone.

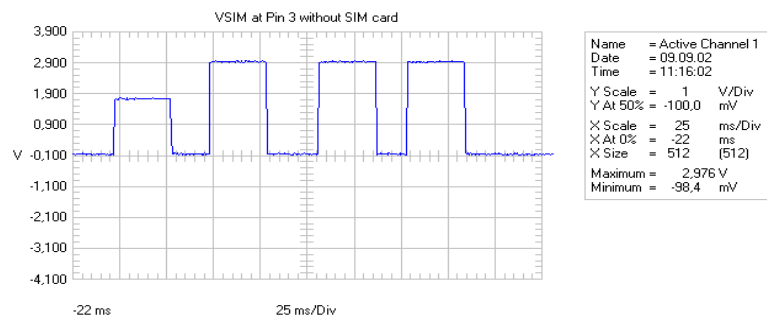
Check VSIM = 3VDC at X386 Pin3.

VSIM **Figure 3**
Delay: 22ms singel shot activ

If not ok, check R386, C203, C390 and X386 for shorts, disconnetions and mechanical damages, and change or resolder faulty components if necessary.

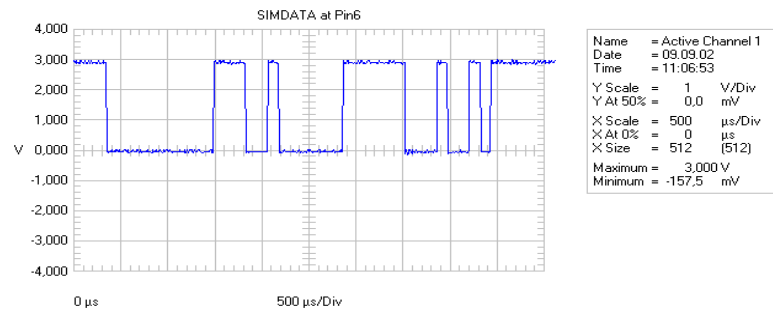
SIMDATA at X386 Pin6

SIMDATA (example) Figure 4

If any of the signals above is not measurable, change R388. If the fault persists after changing R388, change UEM D200.

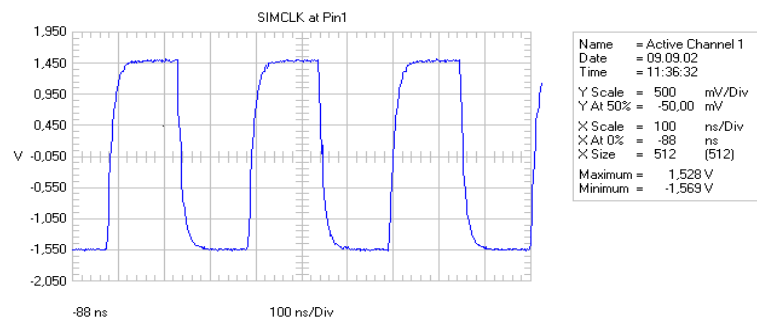
SIMCLK Figure 5

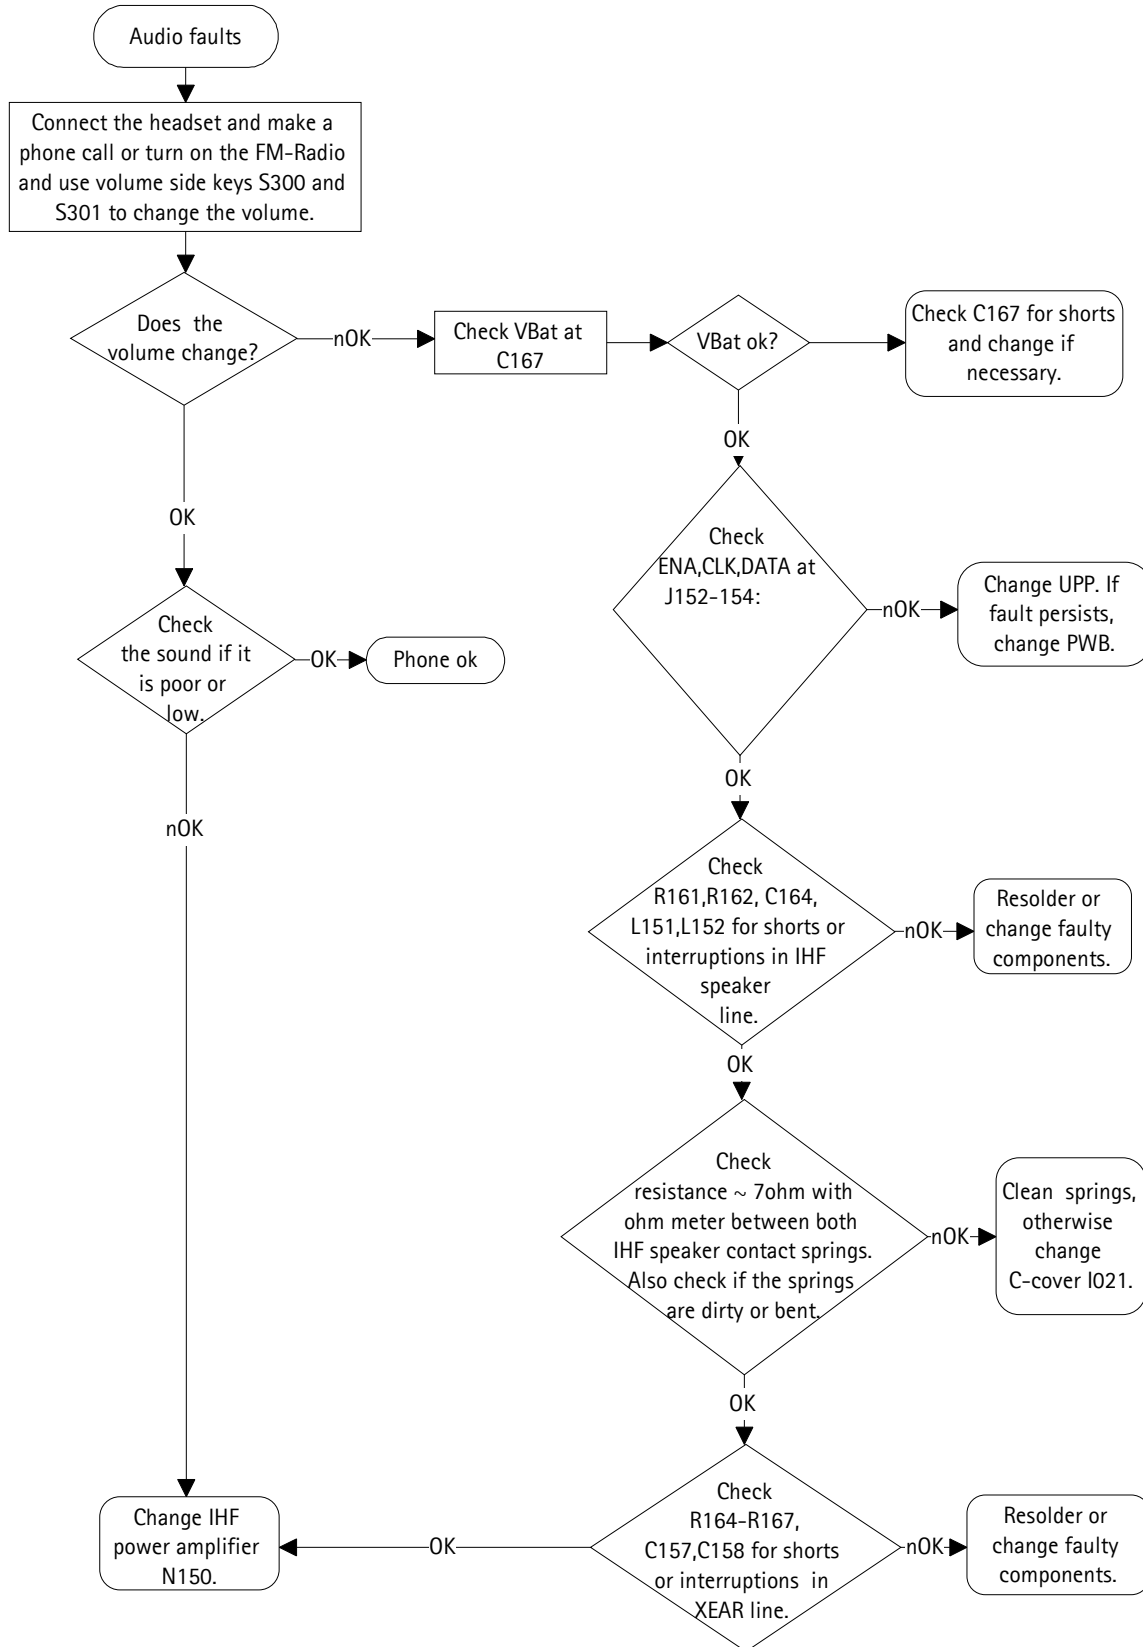
Flowchart audio faults

If no stereo sound is audible; **expecially no sound on left side**; check C162 if not assembled or broken.
In this case reassemble or change C162.
If the fault persists, change N150.
